Army Lodging Wellness Recommendation

Final Submittal - Hunter Army Airfield

March 17, 2004

Hunter Army Airfield

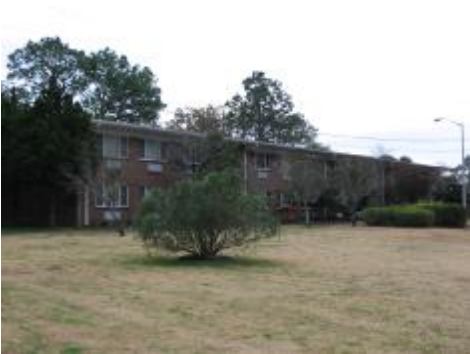
Building 6005, constructed in 1959, is a 2-story brick facility housing 16 family suites and 8 extended stay guest rooms. Although this facility was renovated in 1981, it does not meet Lodging size requirements or provide appropriate support spaces. Based on the use of concrete masonry unit interior partitions, this building cannot be reconfigured without significant reconstruction. To renovate Building 6005 to the new standards and configuration will exceed 50% of the replacement cost.

Our recommendation is to remove building 6005 from the Lodging inventory, allowing the installation to determine an alternate use for this facility. This facility will be removed from the Hunter Army Airfield Wellness Solution and Lodging Master Plan.

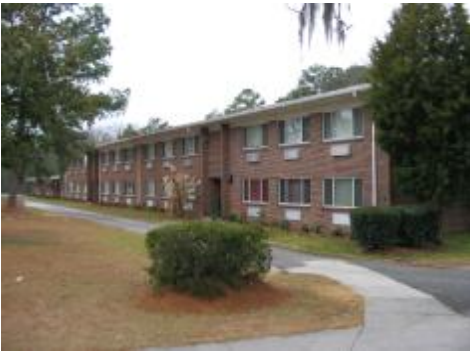
Building 6010, constructed in 1959, is a 2-story brick facility housing 16 family suites and 2 extended stay guest rooms. This facility is the main Lodging Facility on the installation. Although this facility was renovated in 1981, the building does not meet Lodging size requirements or provide appropriate support spaces. Based on the use of concrete masonry unit interior partitions, this building cannot be reconfigured without significant reconstruction. To renovate Building 6010 to the new standards and configuration will exceed 50% of the replacement cost.

Our recommendation is to remove building 6010 from the Lodging inventory, allowing the installation to determine an alternate use for this facility. This facility will be removed from the Hunter Army Airfield Wellness Solution and Lodging Master Plan.

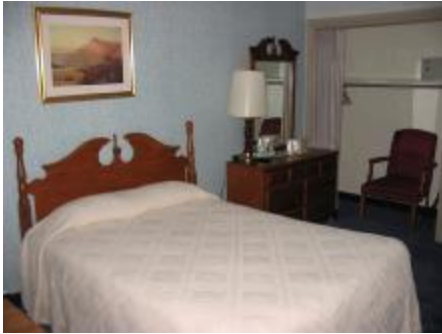
Building 6005
Typical guest bedroom

- Analysis: The hard goods, installed in 1998, consist of a headboard, night stand, dresser, easy chair, fabric covered side chair, desk, and entertainment unit. The soft goods, also installed in 1998, consist of drapes and shear drapes on the windows, TV, mattress and box springs and bed coverings. Multi-room units have a small kitchen which includes a two burner electric stove top. All are in fair condition.
- Recommendation: Replace all hard and soft goods in guest rooms.

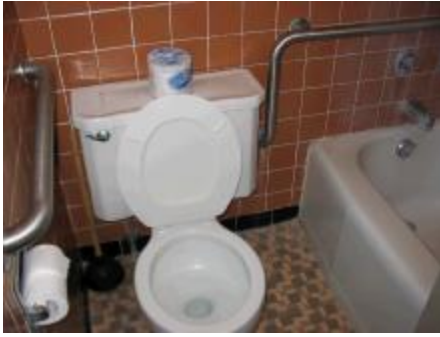
Building 6005
Typical guest bathroom

- Analysis: The guest bathrooms have a sink with vanity, floor mounted water closet and a shower, all installed in 1981. The fixtures are in fair condition.
- Recommendation: Replace all fixtures and add bathtubs to meet CFSC standards.
